## Failure Investigation of a Geosynthetic-Reinforced Soil Slope Subjected to Heavy Rainfall

A webinar titled “Failure Investigation of a Geosynthetic-Reinforced Soil Slope subjected to Heavy Rainfall” was organized by Geotechnical Engineering Technical Division (GETD) on 15<sup>th</sup> September 2021. The webinar was delivered by Professor Yang Kuo-Hsin from Department of Civil Engineering at the National Taiwan University (NTU) and has attracted 146 participants.

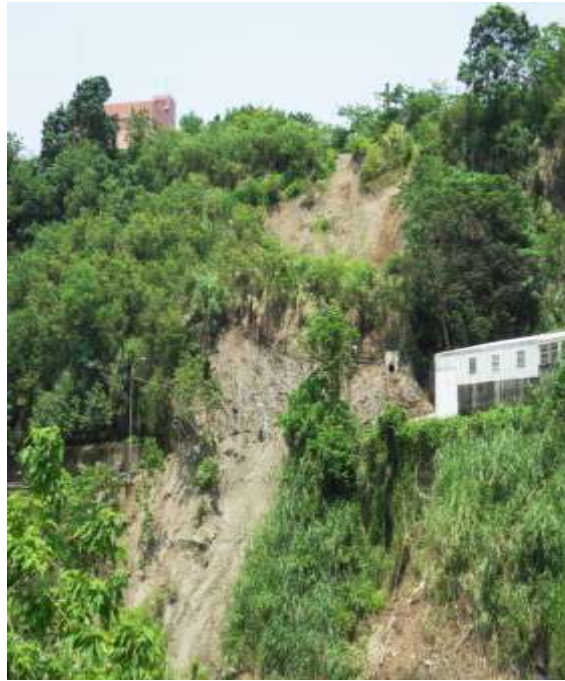
Prof Yang commenced the talk by introducing the background of the failed geosynthetic-reinforced soil (GRS) slope located at Taichung, Taiwan. The 26 m high and 60 m long GRS slope has an inclination angle of approximately 63° was constructed in four-tier and backfilled with low plasticity silty clay with more than 60% fines. The GRS slope first exhibited excessive deformation after typhoons and heavy rainfall from 2010 to 2012. The slope collapsed in 2013 due to two sequential typhoon events with a total accumulated rainfall of more than 600 mm. A compound failure mode was observed where the failure surface partially cut through the reinforced zone and partially passed along the interface between the weathered sandstone and intact shale. The overview of the GRS slope failure is shown in Figure 1.

Figure 1: Multi-tier reinforced slope failure in Taichung, Taiwan on 1<sup>st</sup> Sept 2013

Prof Yang continued the discussion on the parametric studies conducted to examine the three remedial measures namely soil nail stabilized weathered layer, efficient drainage system and good draining backfill to improve the drainage capacity and slope stability of the GRS slope during rainfall. All the remedial measures were found to be able to enhance the slope stability during rainfall effectively. The results also demonstrated that efficient drainage system and good draining backfill measures can improve the drainage capacity of the GRS slope and this facilitate the pore water pressure dissipation especially at the toe of the slope.

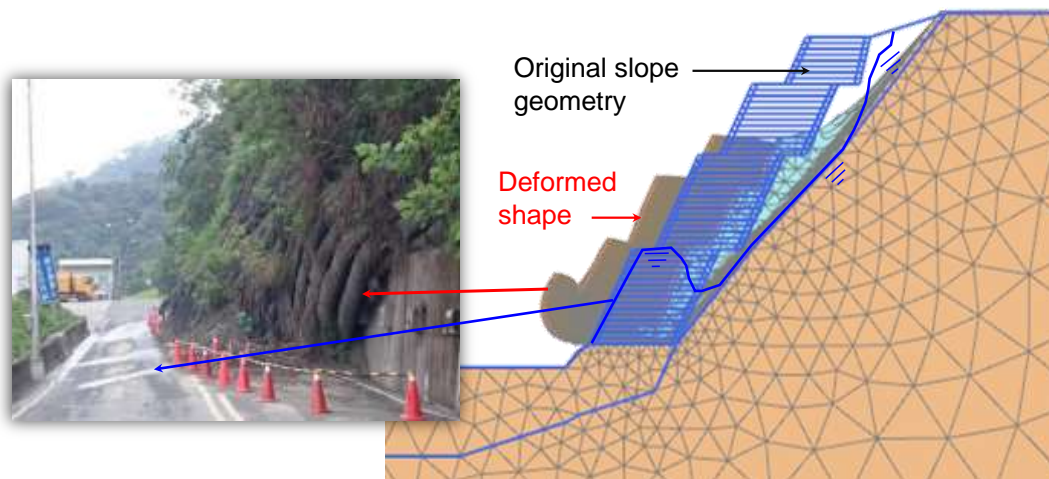
The speaker then discussed on the conventional limit equilibrium analysis used to back analyzed the failed GRS. It was observed that this approach has some disadvantages such as misinterpretation on the failure mechanism, inaccurate factor of safety and unable to consider drainage in the remedial measures. Hence, the coupled hydro-mechanical finite element analysis that consider the theories of unsaturated soil mechanics was adopted. This approach was able to predict the failure timing accurately and demonstrated good agreement for both the observed and predicted failure surface, deformation and phreatic surface as illustrated in Figure 2.

Figure 2: Model validation for deformed mesh and phreatic surface
