Halfen Moment Factory Technical Visit Report

by Ir. Dr Lee Yun Fook

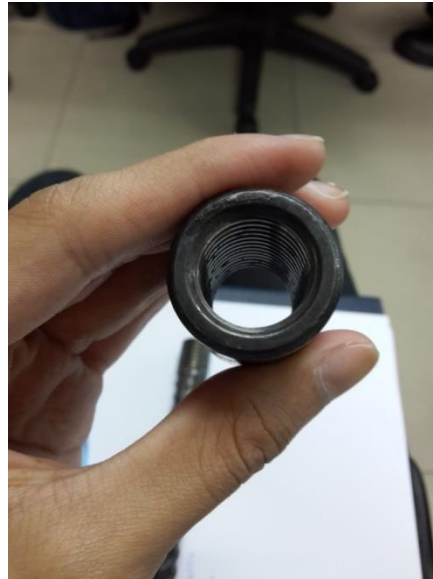
Moment® JoinTec Coupler

After the brief introduction, the speaker proceeded to explain the different types of coupler and threading. The speaker first explained about the applications of coupler, followed by the comparison between lapped splice and mechanical splice. Lapped splices depend on concrete for strength, and

therefore lacking in structural integrity and continuity while mechanical splices provide the assurance of maintaining load-path continuity of the structural reinforcement, independent of the condition or existence of concrete. He emphasized on the benefits of using mechanical splice which reduce the splicing cost, time and congestion. He also highlighted some case studies of constructions sites that use their products. A few samples of coupler were distributed to the participants during the talk.

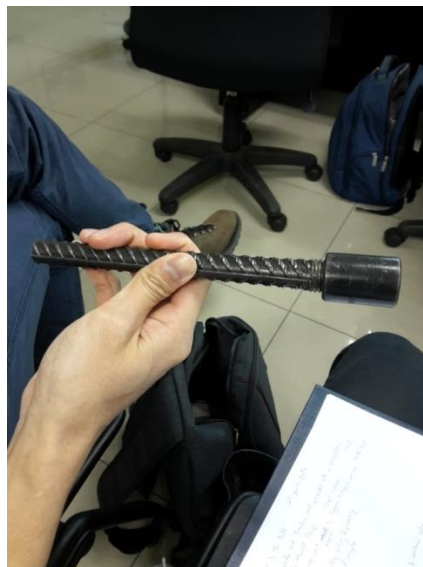
A Moment® JoinTec Coupler Mounted on Threaded Steel Bar

The speaker stated that Halfen Moment (M) Sdn Bhd manufactured couplers were in accordance with the highest standards of quality and conformance, i.e. ISO 15835 – 2009 and AC 133. Their couplers had undergone testing such as strength test, slip test, seismic test and dynamic test in laboratory. From the

tests, it is noted that the failure happened on the reinforcement bar which indicates that the couplers manufactured are safe. The speaker continued by introducing other products such as Moment® JoinTec, Moment® MBC and Moment® Grout Coupler. A short question and answer (Q&A) session took place after the briefing to allow the participants to raise their questions and comments. The session ended with a group photo between Halfen Moment representatives and all the participants.

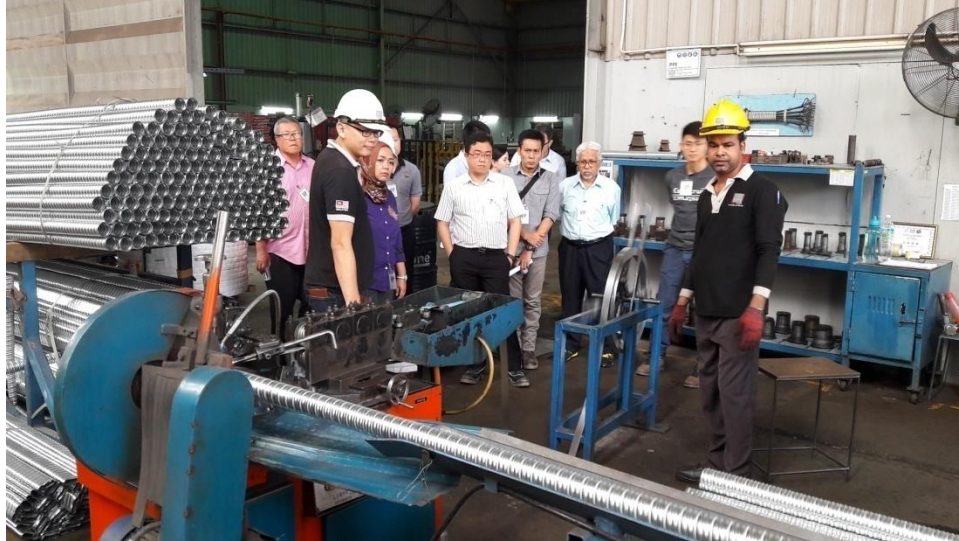
Participants Witnessing The Process of Manufacturing Duct

After the photo session, the speaker briefed about the factory layout and participants were split into 2 groups for the factory visit lead by Mr Tony Toh and Mr KC Loh. During the factory visit, the participants have the opportunities to witness the processes and equipment used for the production of ducts and threaded steel bars.
